Bill Kearns, EMD (Ret.)
Grafton, VT

Photos

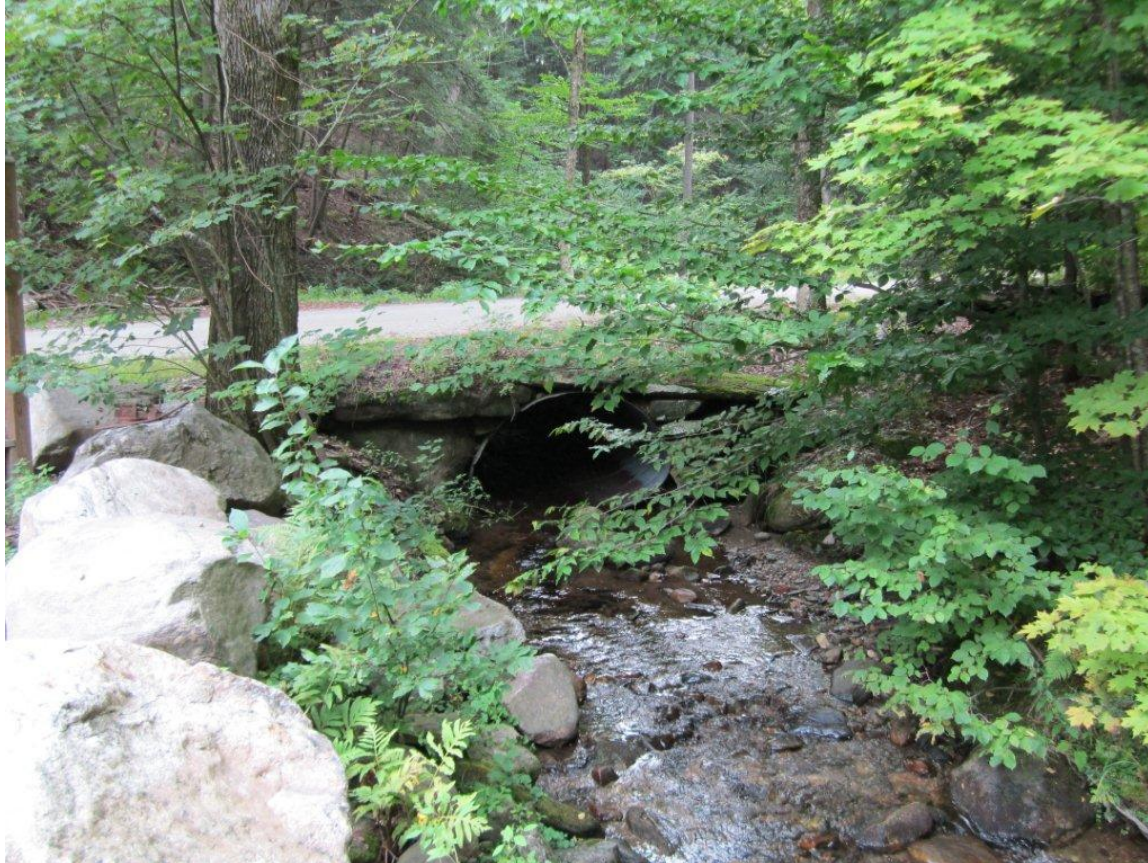
The culvert before August 28th, 2011

6' Culvert (crushed)

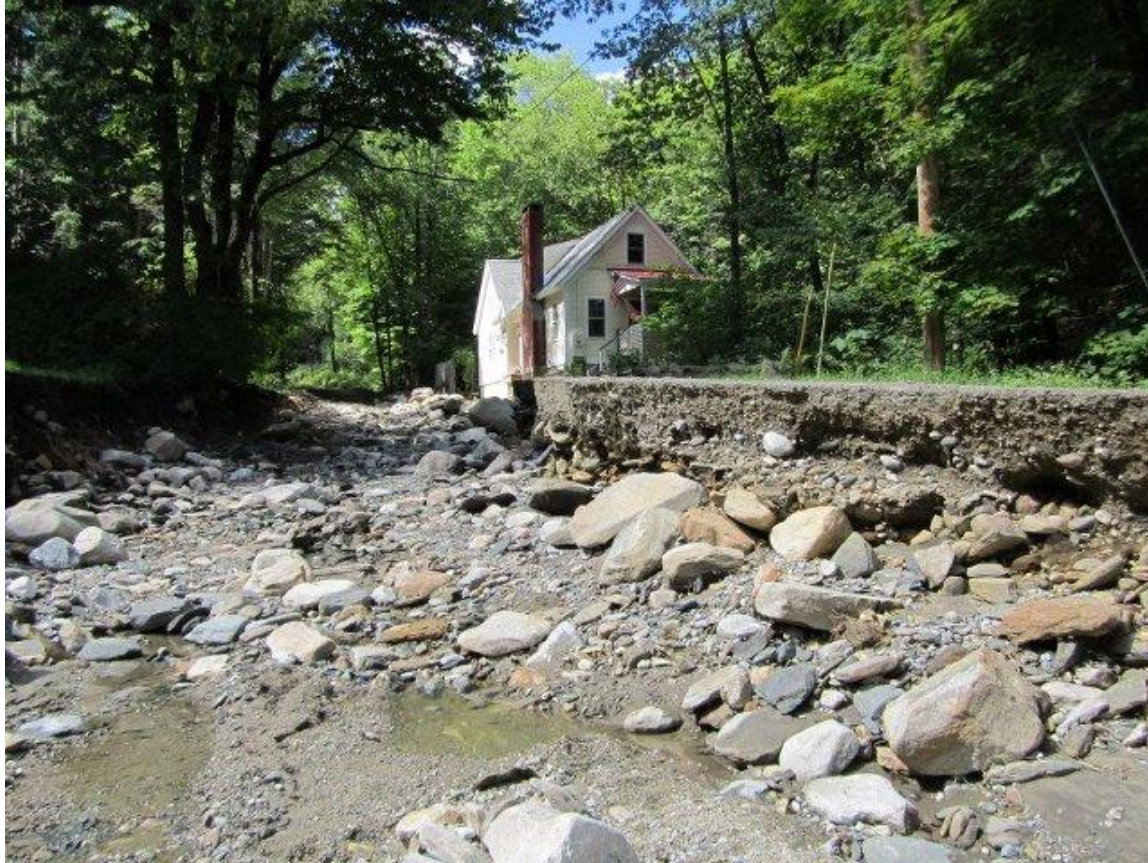
Hinkley Brook Rd. Just below 300 HB Road 8/28/11

Hinkley Brook left the streambed because of the undersized culvert and followed gravity. 45 of 55 miles of road impassable. Typical. Culvert unplugged and temporarily in place, until replacement.

“The Swan” and all the flowers and plants gone. Foundation exposed.

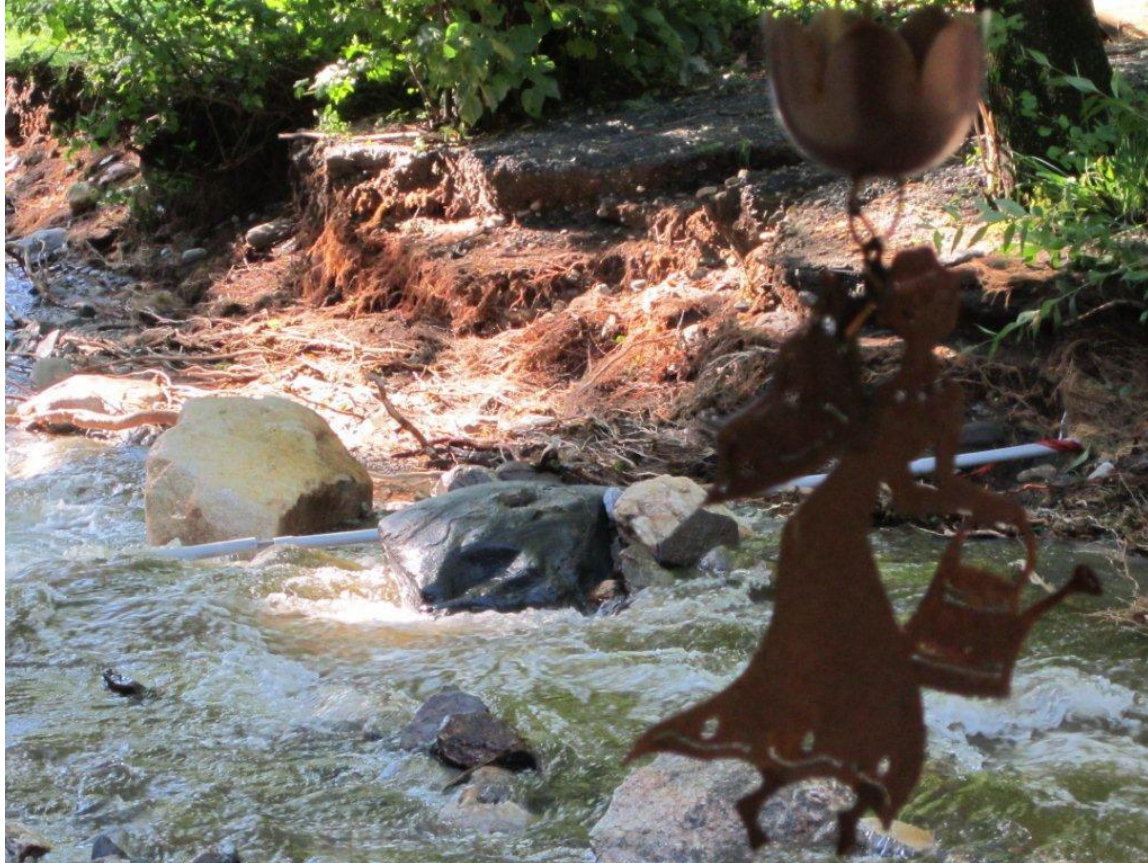
Hinkley Brook Road from the front door of 300 HB Road.

This was taken while the brook was still using the road as a streambed. The culvert disheveled and bent.

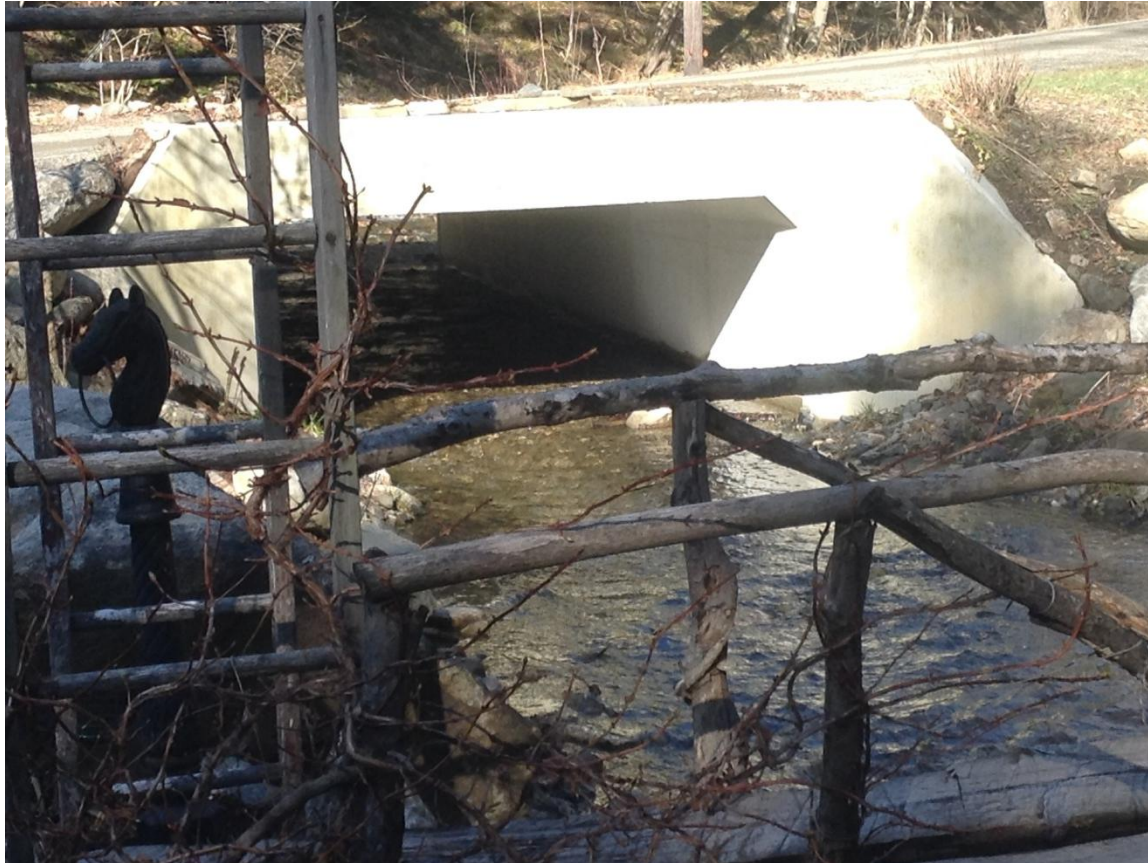
New box culvert completed July 2012

FEMA would not accept the Hydraulics and Hydrology Report, and would not accept the fact that Grafton could receive a permit to install a culvert that did not meet the H&H requirements. (6' x 14' opening, buried 1') Grafton built the project because ANR and our road standards required H&H approved structure. Grafton appealed. Townshend earlier appealed to FEMA HQ (DC) and won a similar appeal. Region 1 FEMA then capitulated. Note width to stream banks.

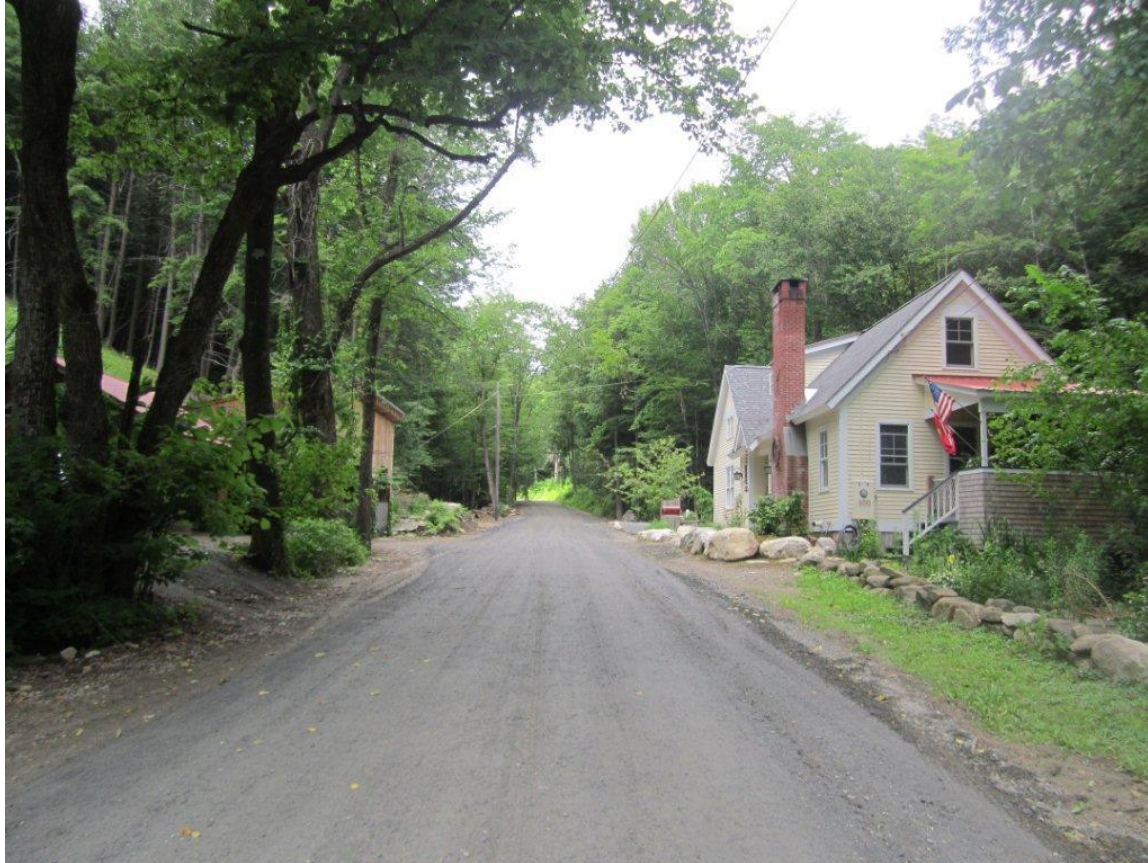
Hinkley Brook Road in August 2012

This was the last recovery project in Grafton.

FEMA appeal not settled till Spring 2013.

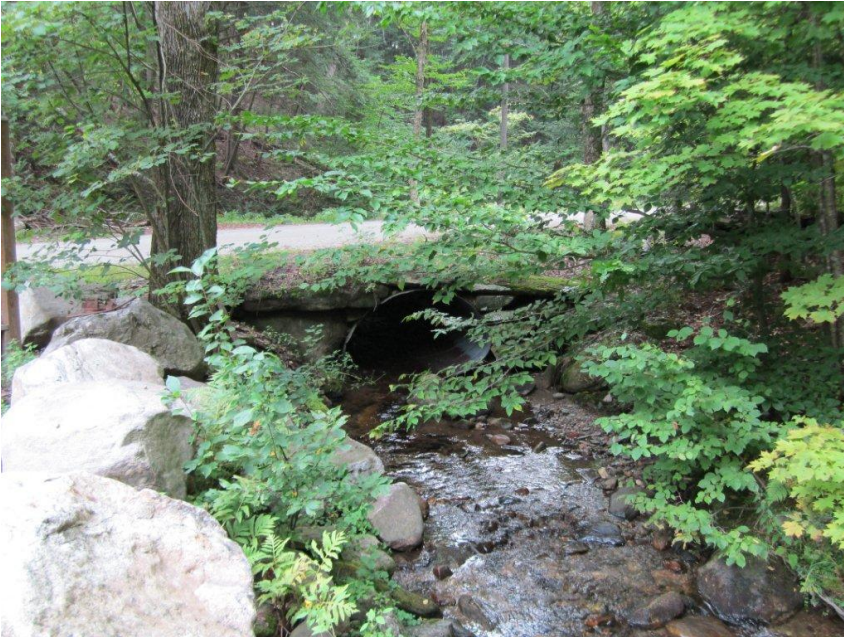
Original culvert

Culvert Comparison

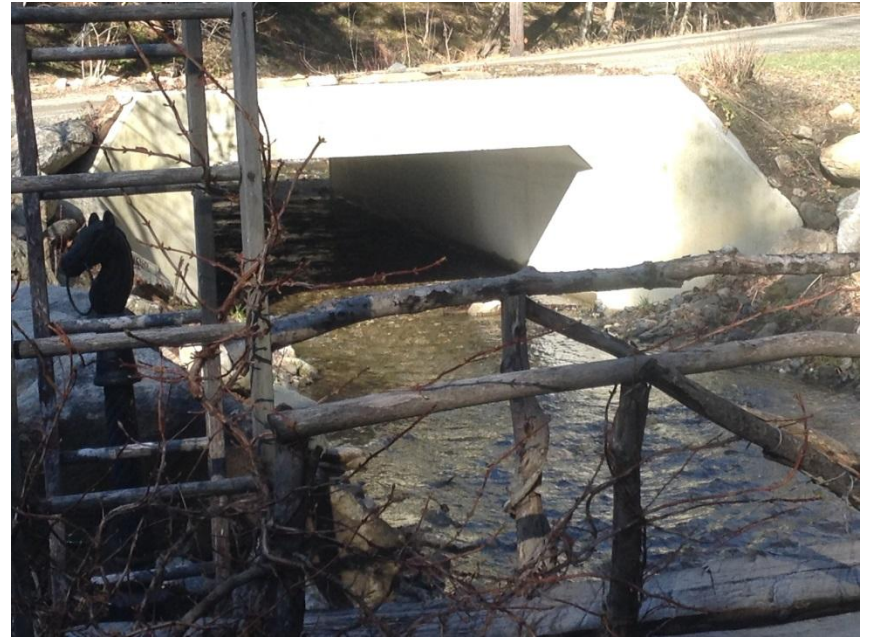
**New Hydraulics and Hydrology
Report compliant.**
